WELL SITING SUMMARY REPORT FOR

# PINEDALE ESTATES DOMESTIC WATER IMPROVEMENT DISTRICT

# NAVAJO COUNTY, ARIZONA

# Project No. 2020-0202

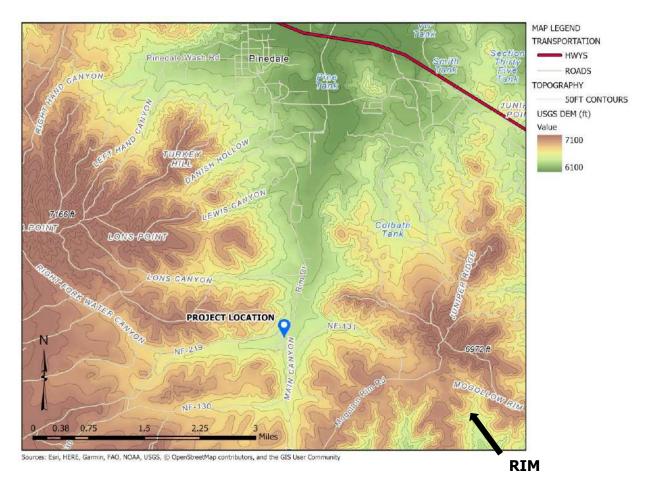
Figure B: Site Vicinity Topographic Map With 50-ft Contours

Refer to Figure B and Appendix A for site vicinity topographic map.

Pinedale Estates is situated in a depression between Lons Point to the west and Juniper Ridge to the east at approximately 6,550-ft in elevation. The Lons Point rises to an elevation of over 7,166-ft and Juniper Ridge is approximately 7,050-ft at its highest point. Most of the parcels within Pinedale Estates are located between 6,500-ft and 6,630-ft in elevation.

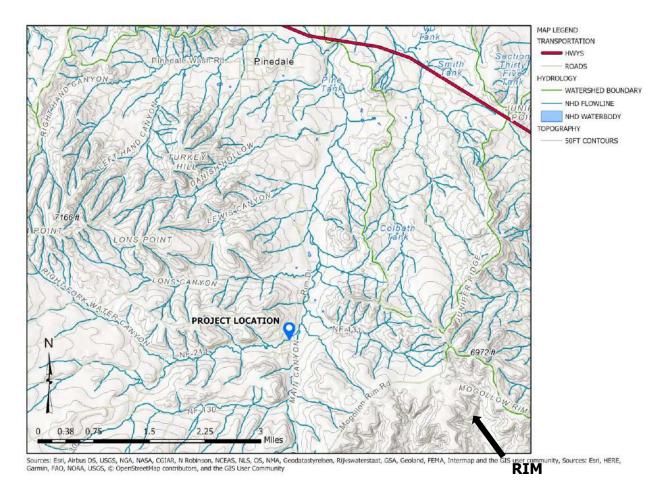
Figure C: Site Vicinity Surface Waters and Watershed Boundaries

The Pinedale Estates community is bisected by Dodson Wash, (also known as Mortenson Wash), an intermittent stream along the Rim Drive as shown in **Figure C**. Engineered With Layton (EWL) interviewed local resident and DWID vice president, Mr. Charles Mead, during an onsite visit regarding flows in the stream due to flooding concerns. Mr. Mead described the flows in the stream as being highly seasonal with high water levels never rising above surrounding riverbanks, several feet below the elevation of the water facility.

Refer to **Figure C** and **Appendix A** for map depicting site vicinity surface waters.

Given the depth of groundwater and the hydrogeology of the region, surface waters are not likely to be a contributing factor to the elevated levels of contaminants at Pinedale Estates.

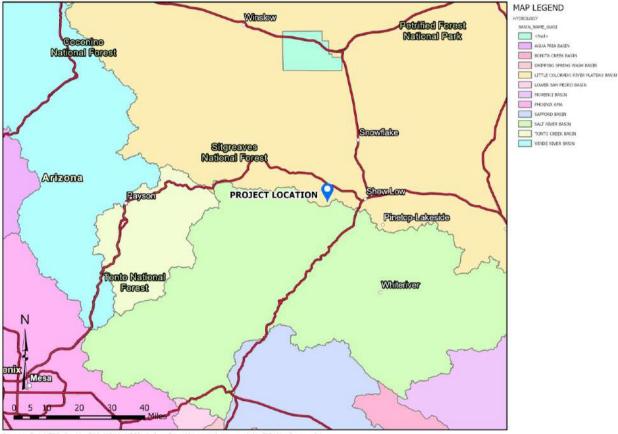
#### Figure D: Groundwater Basin Map of Northern Arizona

The groundwater basins of Northeastern Arizona are shown in **Figure D**.

Pinedale Estates is located within the Little Colorado River Plateau Basin which is part of the larger Colorado Plateau physiographic region (Fenneman et al., 1964). In general, the aquifers of the Colorado Plateau are contained in a thick sequence of sandstone, siltstone and shale. In addition, volcanic rocks, carbonate rocks, and evaporite deposits in the area yield water to wells. Due to structural deformation, faulting and lateral changes in lithology, a complex sequence of water yielding layers have formed overtime (Robson et al., 1987). Within the Colorado Plateau, the four principal aquifers are as follows: Uinta-Animas, Mesaverde, Dakota-Glen Canyon, and Coconino-De Chelly Aquifers (Dane et al., 1965). Although the water quality and availability within these aquifers can vary widely, much of the land is underlain by rocks that contain usable quantities and quality of water suitable for domestic use.

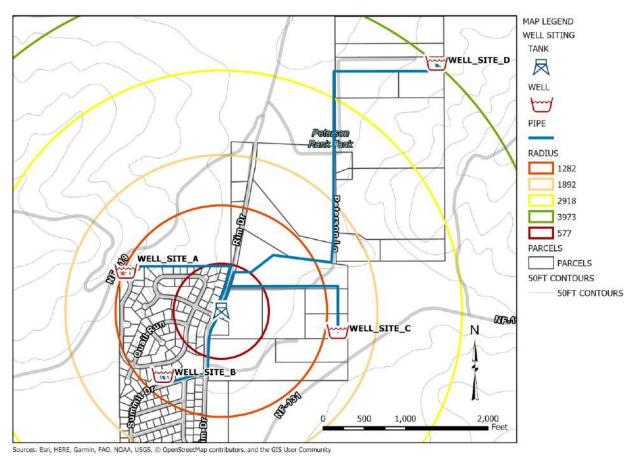
**Figure H: Potential Well Site Locations**

In **Figure F**, there are 4 possible location sites considered in this report for a new Pinedale Estates DWID well. Sites A, B, and C are all within 2000 feet of the current well site, while Site D is approximately 4000 feet away. Sites A, B, and C were location sites given by the DWID as a possibility. In analyzing the water quality data, well sites near Pinedale Estates had higher level of contaminants in the water than well sites further north. If the selenium levels at Pinedale Estates continue to increase, then it is most likely that the areas closest to the well will continue to see an increase as well. Due to the lack of documented wells to the south and east, insufficient data exists to suggest the water quality will improve. Site D has been chosen based on the spatial trend of selenium concentrations, where the groundwater is most likely to be of sufficient quality.

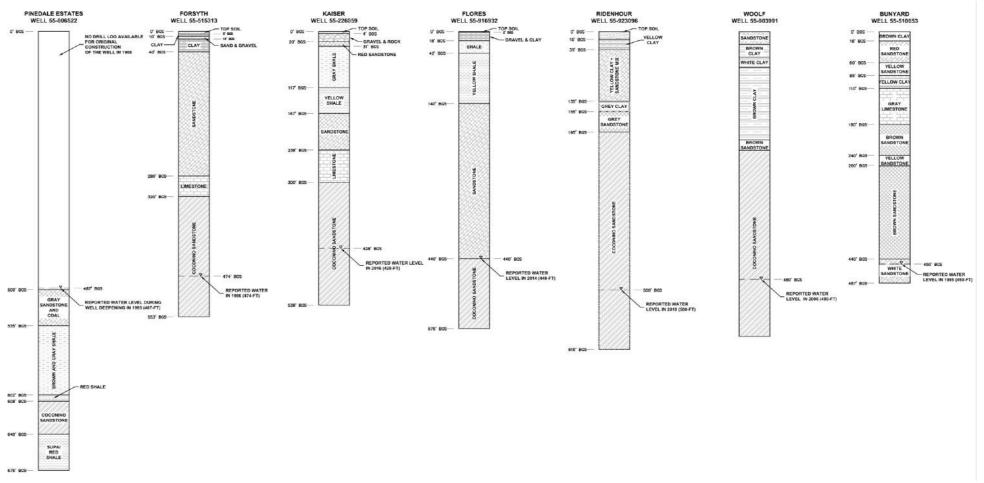
#### Figure I: Drill Logs of Local Wells in Pinedale Estates

Refer to **Figure I** on the following page for a diagram created from the drill logs of Pinedale Estates Well as well as the local privately owned wells.

Analysis of drill logs of nearby wells, including Pinedale Estates, demonstrates similarity in the local stratigraphy. Note that the recorded water level between the wells range from 430- and 480-ft below ground surface in a Sandstone layer. Pinedale Estates well did not have a drill log during the original construction of the well in 1968. However, the consistency of local strata, as shown in **Figure H**, provides a strong predictor for conditions underground at the Pinedale Estates well. Furthermore, given that all wells shown in the figure have consistent groundwater levels, it can be safely assumed that the wells are withdrawing from the same aquifer, eliminating the possibility that the differences in selenium levels are caused by withdrawal from different aquifers.

Outside the Pinedale Estates well, none of the other local drill logs have wells lower than 585-ft below ground surface level. The deepest strata that they penetrate is the Sandstone, between 40and 80-ft below the reported water level during their original construction. Meanwhile, the Pinedale Estates well deepening log notes presence of coal and shale in its deepest strata. The well is nearly 200-ft below the reported water level when the well was deepened in 1995.

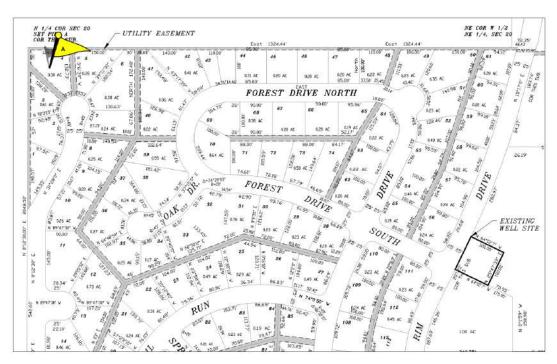
Figure J: Parcel Map showing recorded easements around Well Site A

At proposed well site A, all the adjacent parcels are privately owned and not by the Pinedale Estates Property Owners Association (PEPOA). The northern boundary of the subdivision is set apart for public utility easements. Refer to **Figure J** for recorded easements near Well Site A. It should be noted that satellite images show existing development that extends beyond the recorded easement. If the recorded easement cannot be utilized, special permission from the United States Forest Service may be required to construct the water line further to the north. This route of connection requires approximately 1,956-ft of pipe to be constructed.

Alternatively, the water line may be constructed southward towards Ridge Drive then east across the existing easement between Lot 7 and Lot 8 to Forest Drive, where the rest of the connection can be completed within the roadway.

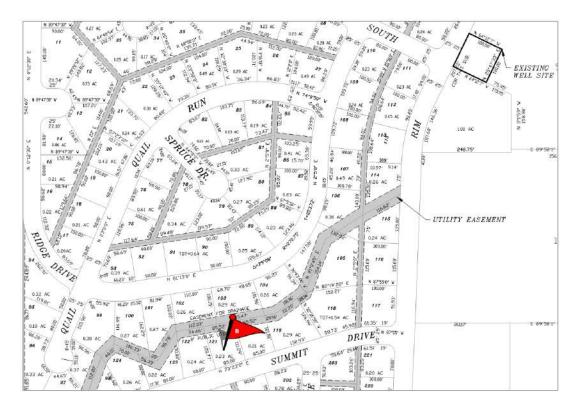
Figure K: Parcel Map showing recorded easements around Well Site B

The closest potential parcel that closely resembles the same size as the current location would be parcel 409-12-121. This current parcel is sized over 10,000 square feet and is owned by the PEPOA. As shown in **Figure K**, there are recorded easements along lots on Summit Drive that provide a direct connection to Rim Road. Connecting Site B to the existing facility will require approximately 1,421-ft of pipe to be constructed. Alternatively, the water line may be constructed along Summit Drive and Rim Road where no utility easements are required.

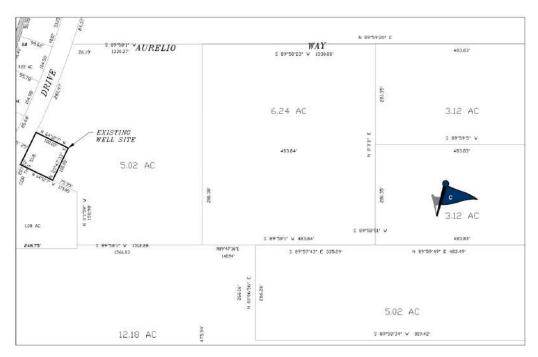
Figure L: Parcel Map showing recorded easements around Well Site C

Site C is a moderate distance away from the original well site with relatively simple pipe alignment. The site is currently on private land owned by the owners of the Melton well. Private land purchase or land lease from the owners would be required to construct a well at Site C. Furthermore, there are no known easements that connect Site C to Aurelio Way. New utility easements dedications may be required in order to connect Site C to the existing well site. The most feasible pathway of connection between Site C and the existing facility will require 2,189-ft of pipe to be constructed. Refer to **Figure L** for recorded easements near Well Site C.

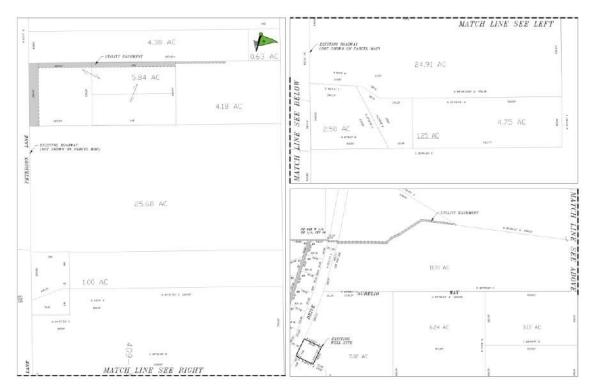
Figure M: Parcel Map showing recorded easements around Well Site D

There are several recorded utility easements as well as existing roadways between Site D and the existing well site as shown in **Figure M** below. However, the extent of the known easements are unclear and no New easements may also be needed between the current well site and Site D. The most feasible pathway of connection between Site D and the existing facility will require 5,243-ft of pipe to be constructed.

This site offers the possibility of the best water quality results as compared to the other options. Wells in close proximity to this site, Ridenhour and Woolf, did not have report elevated levels of selenium. The most significant challenge with respect to Site D is the distance from the current well site. Due to the remote location of Site D, the construction costs associated with water line is higher.

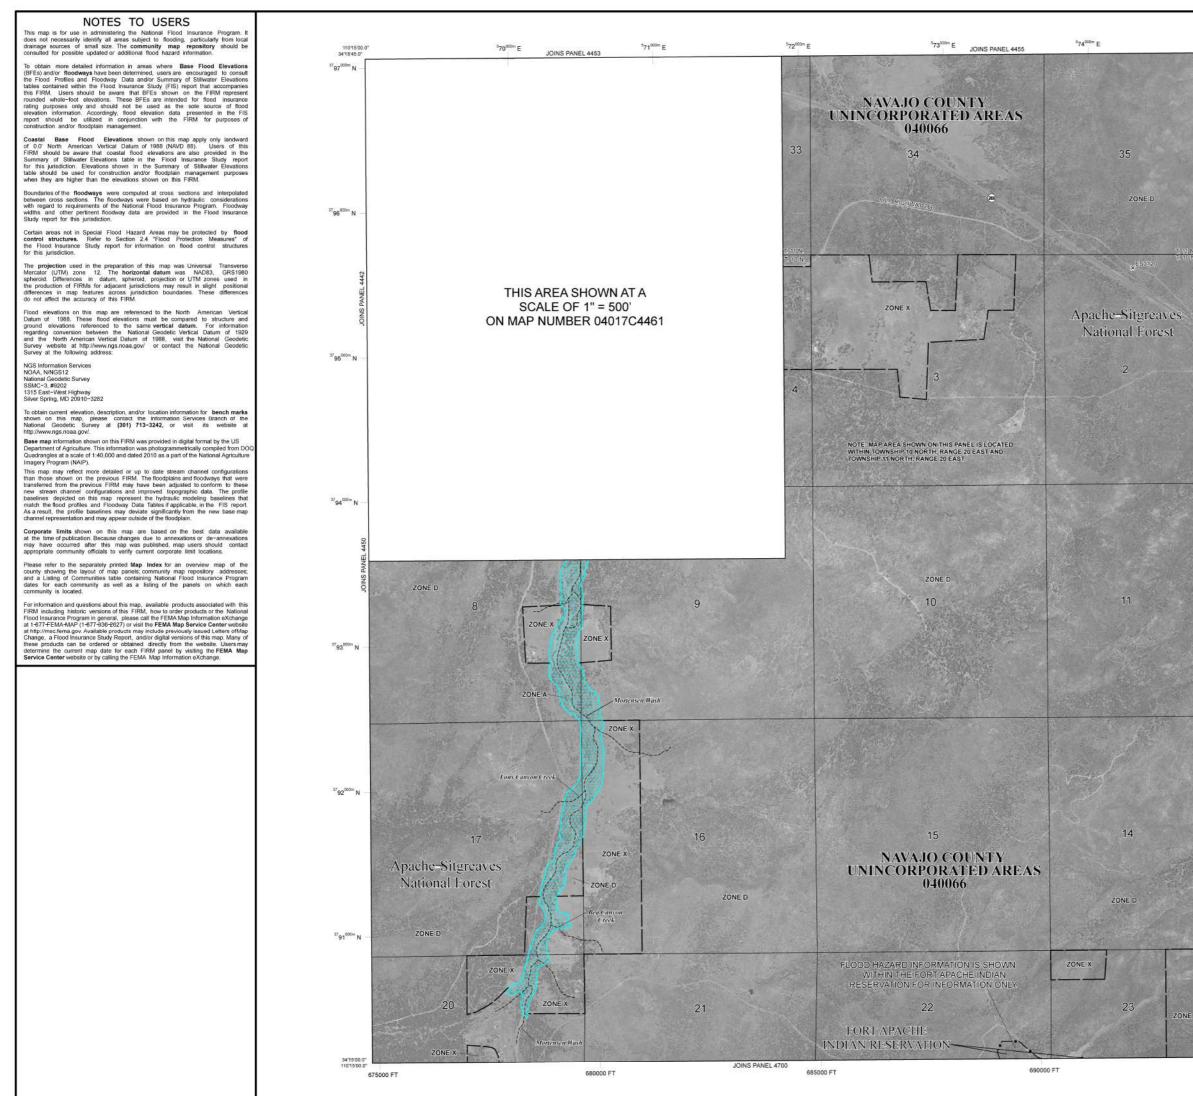
FEMA FLOOD MAP

FEMA floodplain map shows the project area is in Zone A, an area with 1% annual chance flood hazard. Refer to **Appendix B** for the FEMA flood map (FEMA FIRM Map #04017C4442F).
